GALVABAR®

Galvanized Repair Guidelines Using Zinc-rich Paint Reference ASTM A780/M780

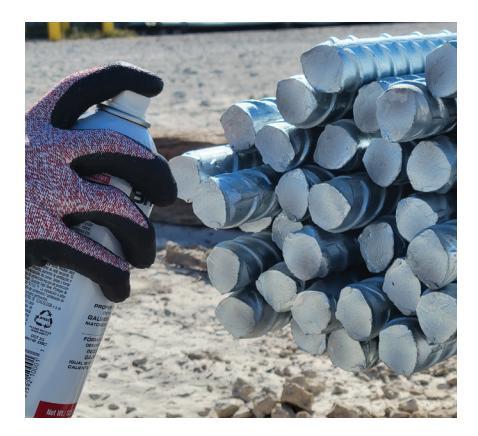
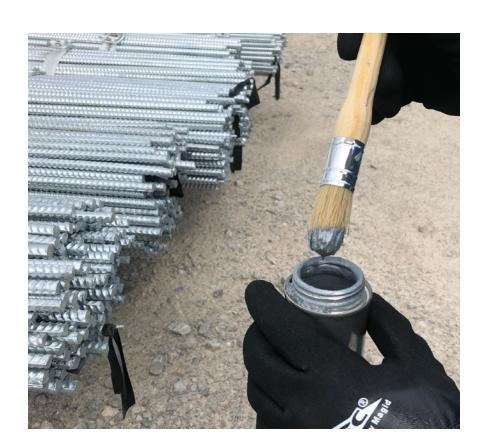
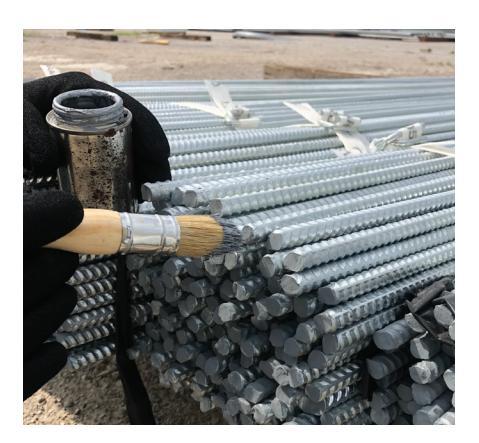
The GalvaBar coating is tenacious and resistant to scratching and chipping during shipping and placement. Typically only cut ends need touch-up in the field because of zinc's cathodic protection ability.

- 1. Surfaces to be repaired using zinc-rich paint shall be clean, dry, and free of oil, grease, preexisting paint, and corrosion by-products.
- Spray or brush-apply the zinc rich paint to the prepared area. Shake or stir prior to use and occasionally during application. Apply the paint as in accordance with the manufacturer's printed instructions in a single application employing multiple passes.
- 3. Allow adequate curing time before subjecting repaired items to service conditions in accordance with the manufacturer's printed instructions.
